COGEAR

Geotechnical measurements in the Matter valley

Del. No.: 3b.2.2

Task 3b.2.2

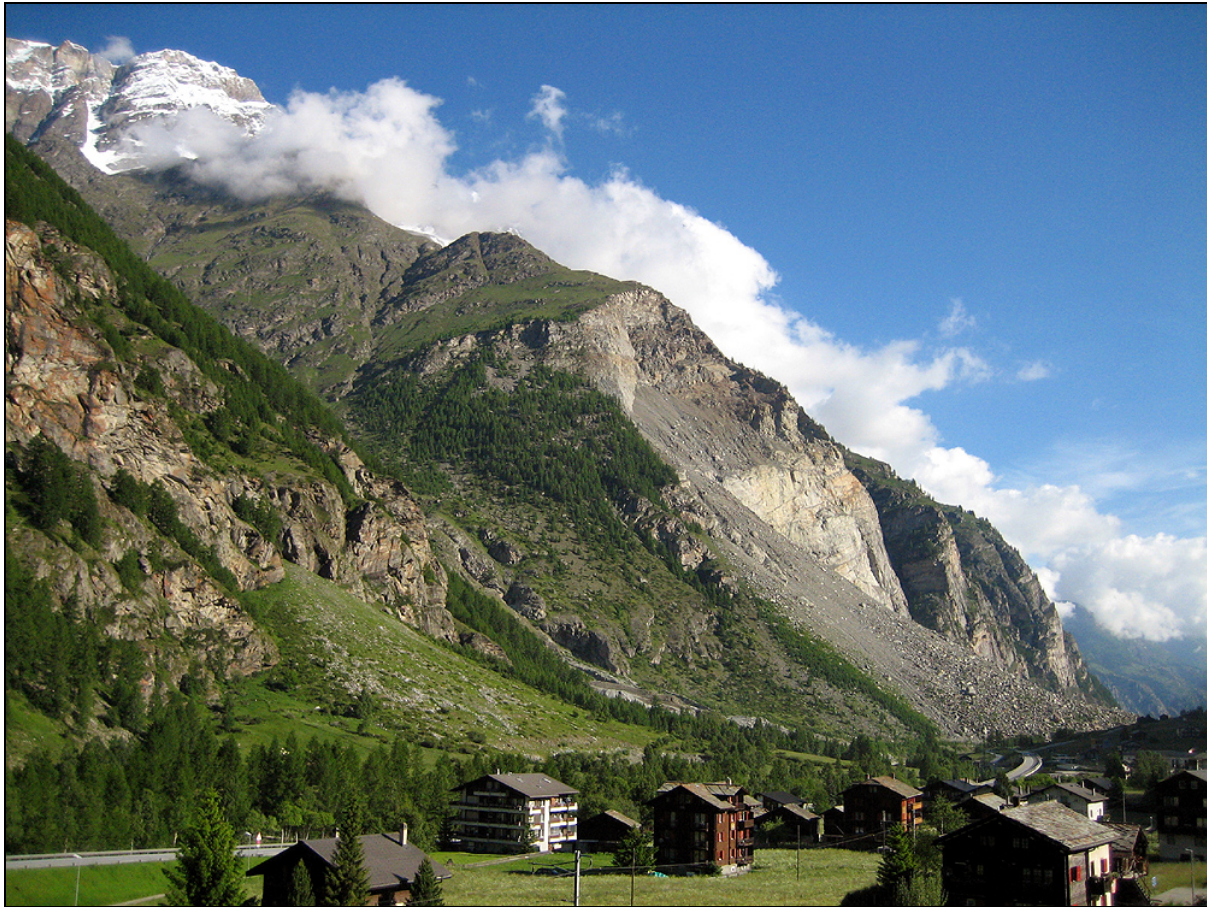
Figure 2: Photograph of the Randa rock slope instability showing the talus deposited during the 1991 failures over the town of Randa, VS.

Since 2001, the Engineering Geology group at ETH Zurich has maintained an 'in-situ laboratory' at the rock slope instability located above the town of Randa in the Matter valley (46.113116° , 7.774713°). The slope failed catastrophically in 1991, releasing around 30 million m^3 of crystalline rock (Figure 2). Currently, we estimate that around 5-7 million m^3 of material remains unstable, moving towards the valley at up to 20 mm/yr (Gischig et al., 2009). Geotechnical measurements aim to describe the key structures controlling rock mass deformation, derive kinematic modes of displacement, and elucidate those mechanisms driving progressive failure.

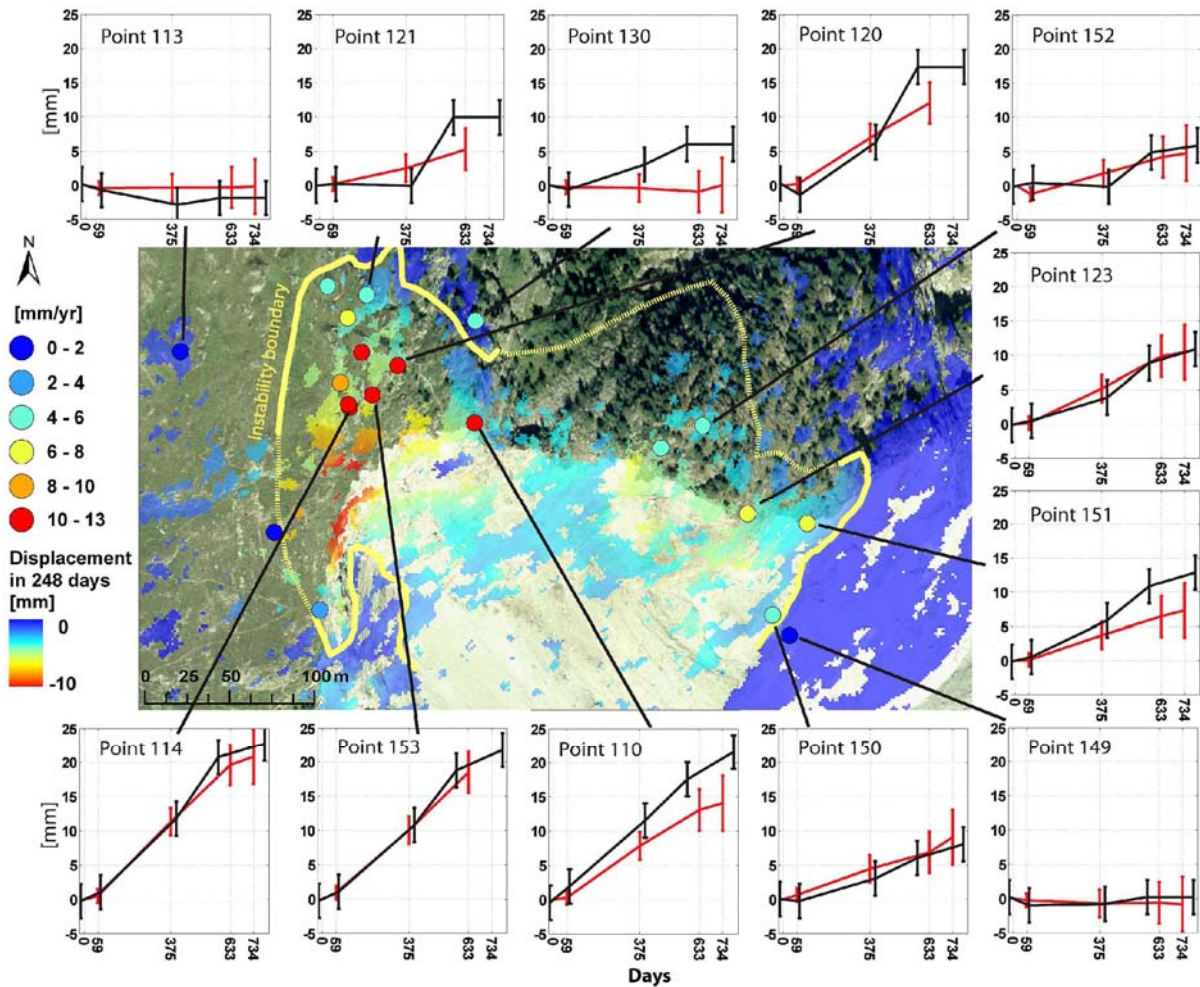
Figure 6: Comparison of geodetic distance measurements with GB-DInSAR displacements at Randa. Time series derived from GB-DInSAR data at the locations of the reflectors are shown in red, geodetic time series are shown in black. Locations of the reflectors are displayed together with an unwrapped displacement map between the 3rd and the 2nd repeat survey (248 days). The yellow line shows the boundary of the instability derived from GB-DInSAR; dashed portions are uncertain. Figure reproduced from Gischig et al., 2009.

Five ground-based differential interferometric synthetic aperture radar (GB-DInSAR) surveys were conducted between 2005 and 2007 at the Randa rock slope instability. GB-DInSAR measurements were conducted by Ellegi Srl (Milano, Italy) using their GB-DInSAR system *LiSA*. The *LiSA* base station was located at 1560 m.a.s.l. on the valley wall opposite the 1991 failure scarp. The system works at a frequency range of 17.1–17.18 GHz. The radar antennas are translated along a 2.7 m long rail in order to create a synthetic aperture. The target distance is 1.3 to 2 km. Azimuth resolution is 4 m in the near range and 6.5 in the far range, range resolution is 1.9 m. Complete system specifications and acquisition parameters for these radar surveys, as well as a full discussion of the results is presented by Gischig et al., (2009). Overview results are presented in Figures 5 and 6.

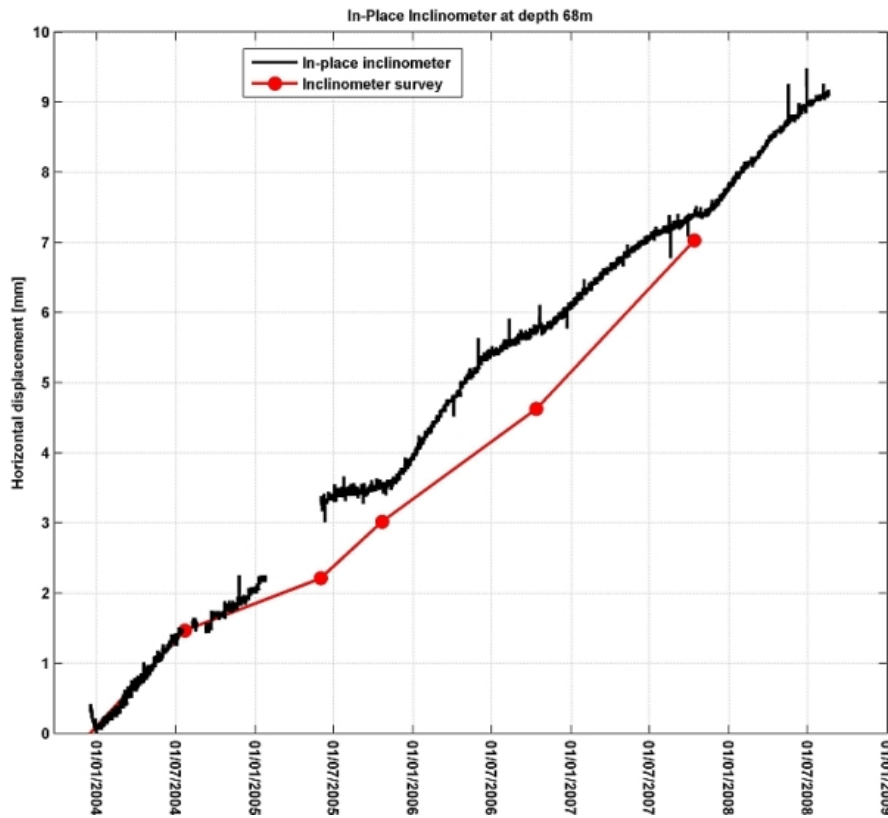
Figure 10: Time series of in-place inclinometer data from Randa borehole sb120. Red line shows the results of periodic inclinometer surveys for comparison.

Two in-place inclinometers (Vibrating Wire, Model 6300 from Geokon) are installed across discontinuities in the deep boreholes at Randa. Their purpose is to monitor continuous displacements across these discontinuities and to detect temporal changes in

the displacement rate. The instruments measure changes in tilt, which allows for computing the horizontal displacement using the base length of the instrument (1.87 m). The inclinometers have been operational since January 2004. Between 2004 and 2008 they were placed at 68 m and 85 m depth in the sb120 borehole. These locations were chosen according to periodic inclinometer surveys, which showed significant displacement across discontinuities at those depths (see Figure 9). The sampling interval in this time period is 1 hour. Detailed description of the measurement system and results can be found in Willenberg et al. (2008a,b), and example results are shown in Figure 10.

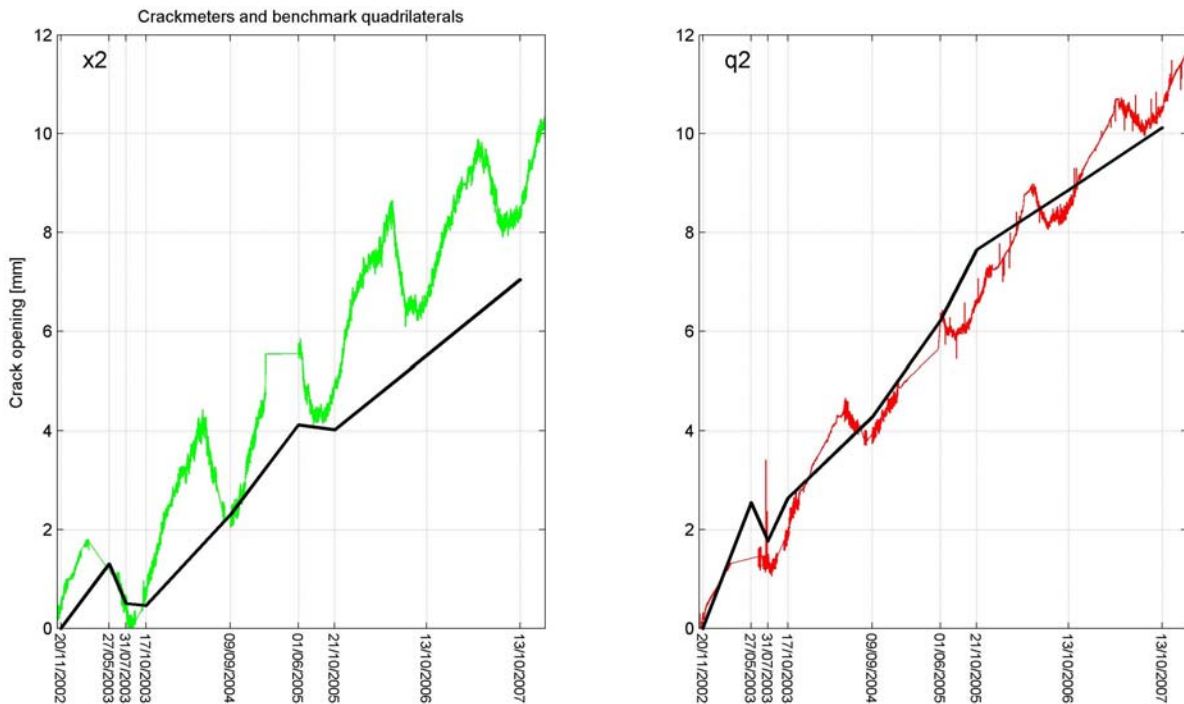
Figure 11: Crack extensometer time series data shown with hand measurements of the benchmark quadrilateral arrays for two cracks (q2 = Z9 and x2 = Z10) at Randa.

Two Vibrating Wire crack extensometers ("crackmeters" - Geokon model 4420) continuously measure opening of two monitored tension cracks at the ground surface (cracks q2 and x2 (also called Z9 and Z10); Figure 8). These sensors have been operational since January 2003 and run at a sampling rate of 1 hour (before August 2008) and 30 min (since August 2008). Resolution is 0.03 mm with a reported accuracy of 0.15 mm. A thermistor is built into each sensor for thermal strain compensation. Both cracks show a strong seasonal pattern of deformation with closure during warming periods and opening during cooler periods. Example data are shown in Figure 11. Detailed description of the measurement system and results can be found in Willenberg et al. (2008b).

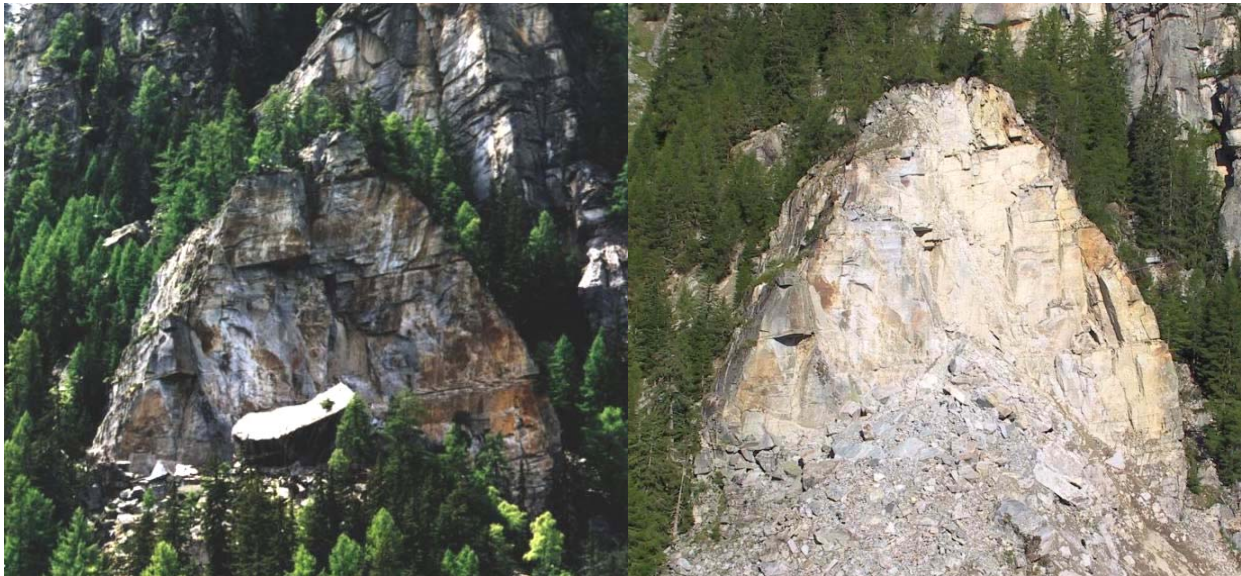
Figure 15: The Medji rock slope in 2000 (left) and in 2002 (right). Figure reproduced from Joerg, 2008, modified from Rovina + partner, 2005.

The Medji rockslide occurred on the evening of November 21, 2002 above the village of St. Niklaus (46.167414°, 7.787053°). In total, 70,000 m³ of rock collapsed from an unstable nose in highly-dissected, steep terrain (Figures 14 and 15). Since 2002, various instabilities remain in the immediate vicinity, controlled by large-scale tectonic faults and fracture zones.

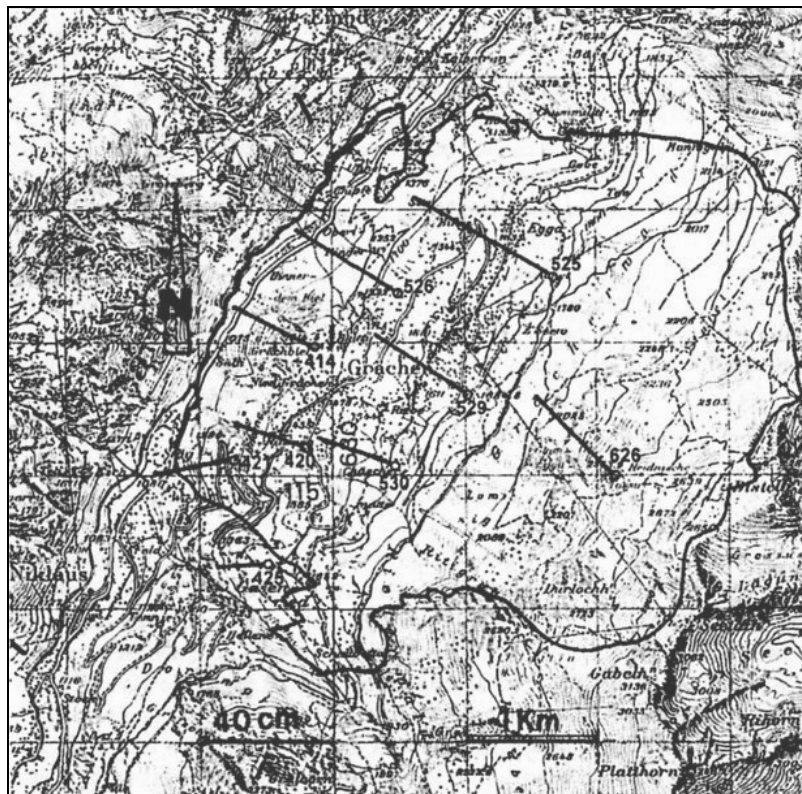
Figure 18: Graechen geodetic monitoring overview. Displacement vectors were calculated over a 62 year period from 1930-1992, and are scaled according to the legend in the lower left portion of the map. Figure reproduced from Noverraz et al. (1998).

Displacements of nine fixed measurement points have been monitored over an interval of 62 years as part of a long-term study. Full results and measurement details are described by Noverraz et al. (1998). The results reveal the first conclusive indication that large mass of the suspected DSGSD at Graechen is currently moving at appreciable rates. Movement rates up to 8 mm/yr were measured, and their distribution helps estimate the limits of the unstable mass (Figure 18). Unfortunately, a denser array of measurement points is not available, and the lateral extents of the DSGSD remain poorly constrained in some areas.

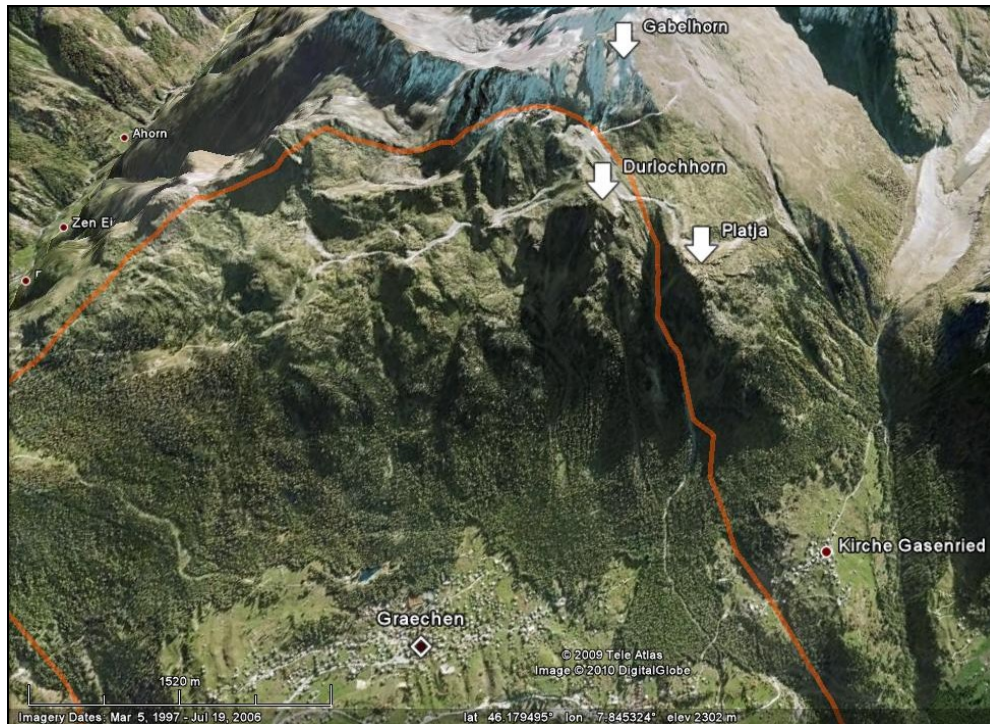
Figure 21: Overview of detail study sites at Graechen selected for time-lapse photography and laser scanning: Gabelhorn, Durlochhorn, and Platja.

Select sites within the Graechen area have been chosen for detailed analysis (Figure 21). Rock slopes on the Durlochhorn and Gabelhorn (near the Seetalhorn lift station) have been selected for time-lapse photography and LiDAR difference surveys as part of a new project regarding rock slope sensitivity (K. Leith). First measurements have been accomplished, with repeat measurements to follow 3-4 times per year. At Platja (Figure 22), a network of large rock blocks separated by wide tension cracks has been investigated as part of an ongoing M.Sc. thesis project (M. Heynen). The crack network and relative displacements are described, and infrastructure for in-situ displacement measurements using a tape extensometer has been installed. Baseline measurements of crack opening were made in 2009, with follow up surveys scheduled for 2010.
